TECHNICAL SERVICE BULLETIN

NO. 1-F-9

DATE: October 1970

MODELS:
Rear Brake Shoes — #5949	Land Rover 109"

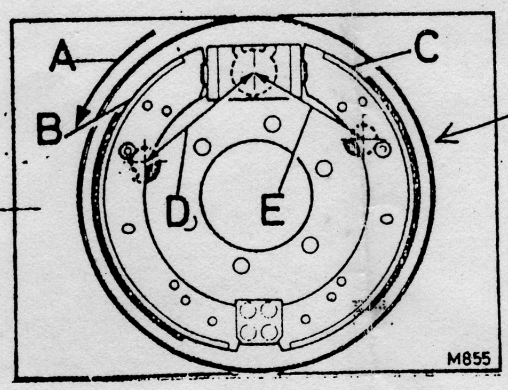
We have received reports of rear brake shoes being refitted the wrong way round with the result that correct adjustment of the rear brakes is not possible. Reference to the illustration below shows the dimensional difference between the location of the shoe lining on the leading and trailing shoes.

Note: Pegs are located differently!

A - Direction of rotation
B - Leading shoe (Note that the leading shoe lining is
C - Trailing shoe (a greater distance from the wheel
(cylinder than that of the trailing shoe

D - 4.5 in.
E - 4.25 in.

It is essential that the rear brake shoes are fitted correctly as illustrated to insure the correct operation of the brake adjustment mechanism.
